⑥ OPERATION CROSSROADS
U.S.S. TUNA (SS203)

TEST BAKER [U] ⁸

BUREAU OF SHIPS GROUP
TECHNICAL INSPECTION REPORT

USS TUNA (SS203)

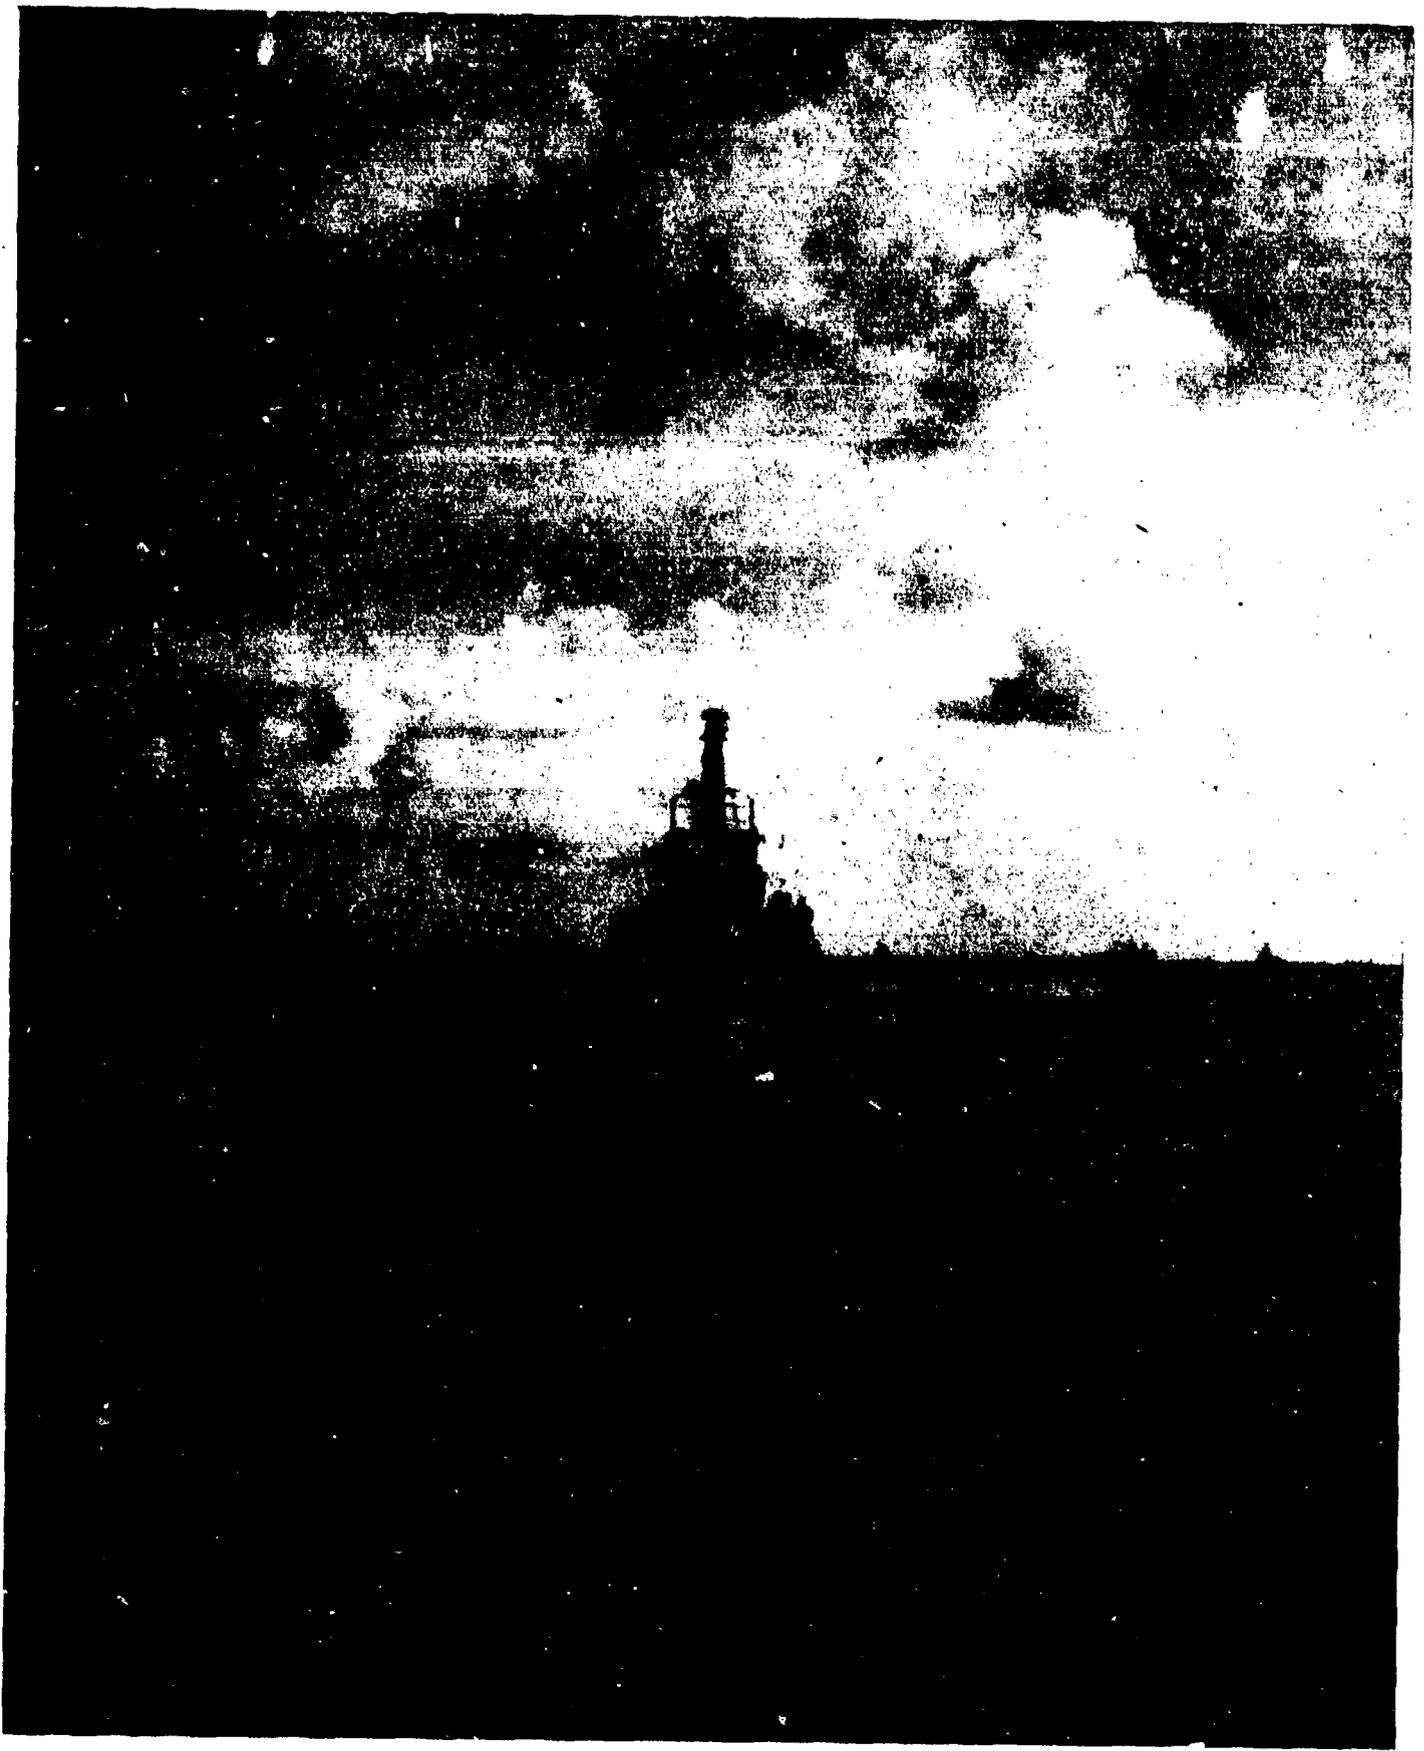
ABCR-227-290-52. General view from ahead.

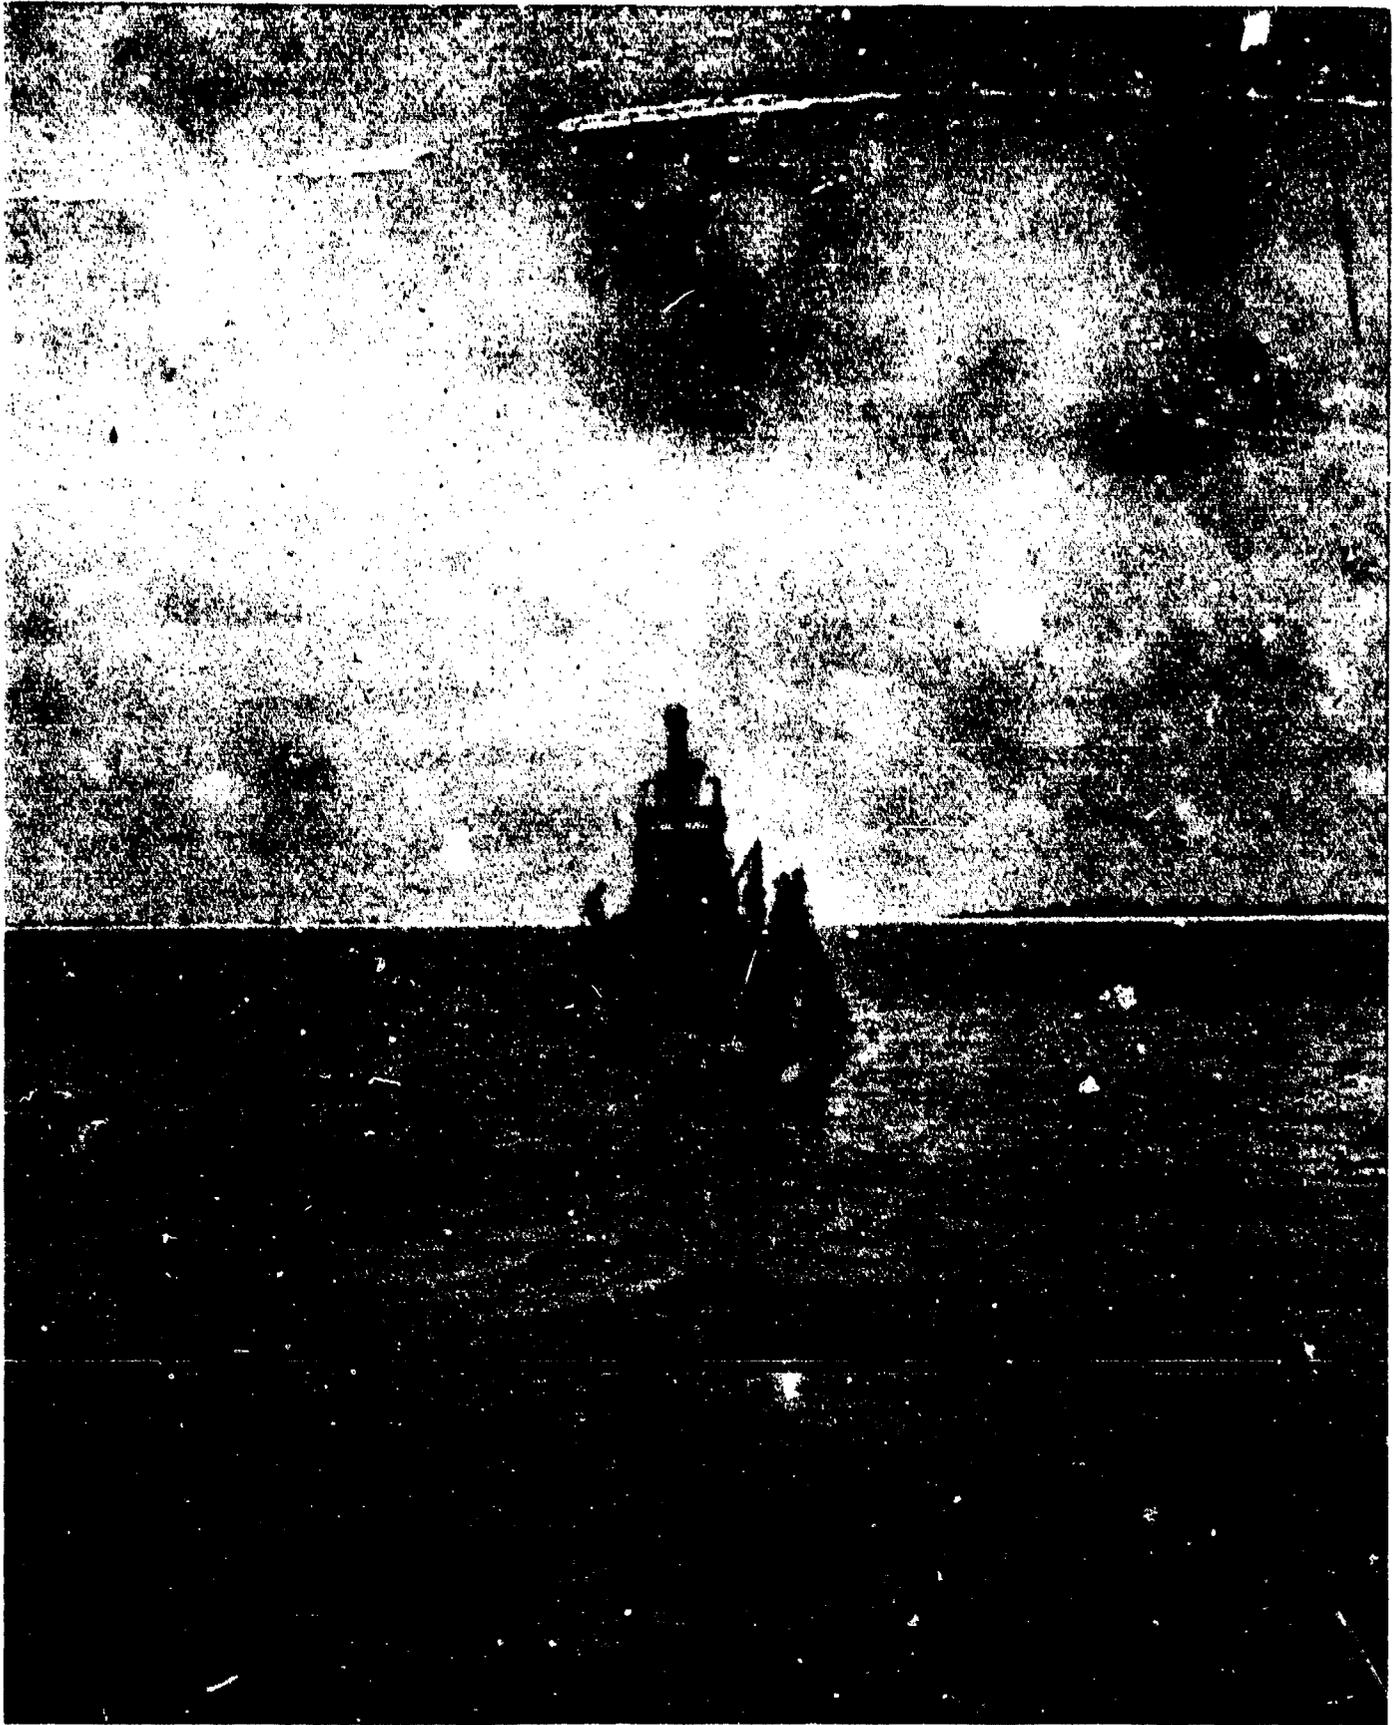
ABCR-227-290-48. General view from astern.
